# **Cedar Creek Reservoir Sediment Density and Channel Erosion Study**

SDI, Inc and Peter M. Allen, John Dunbar, Shane Prochnow and Lisa Zygo, April 2006.

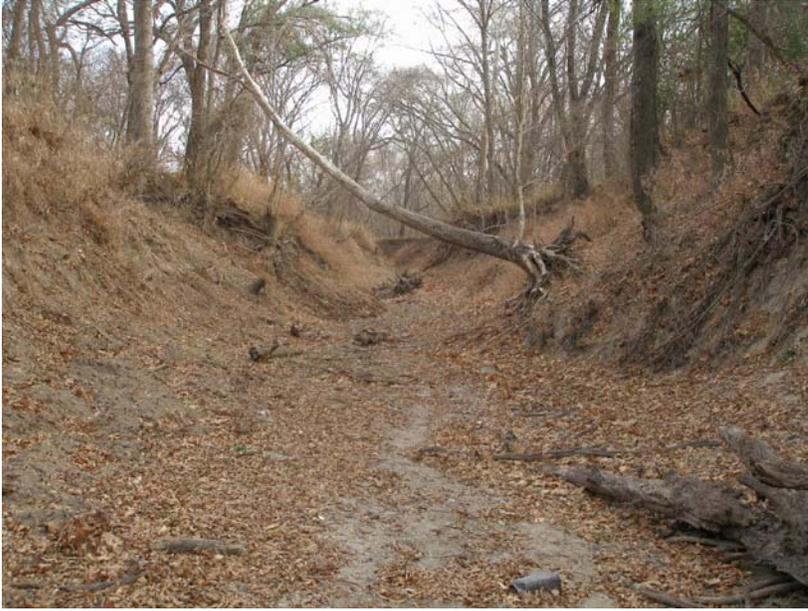
Figure 8. Degrading Channel CEM II-III (Location 19); Sandy loam soils.

Typical channel ratings and sites within the basin are shown in Figures 8 through 11 and given in Appendix. If the channels are moving into stage II-III, erosion should probably be adjusted to reflect sediment loss from both banks and the channel bottom as has been shown by Simon, e.t al. 2004. For this study, all channel erosion was estimated assuming CEM 1 or one channel eroding. It was not felt that resolution of the CEM stages throughout the system was good enough to incorporate the increased erosion into the estimates. (See Conclusions).

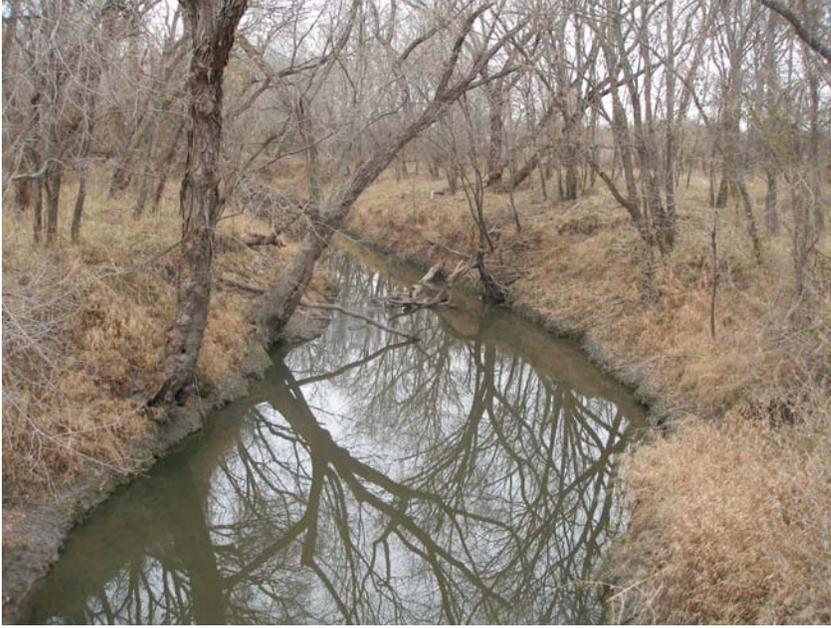
Figure 10. Stable channel; slight erosion; CEM I (Location 21).

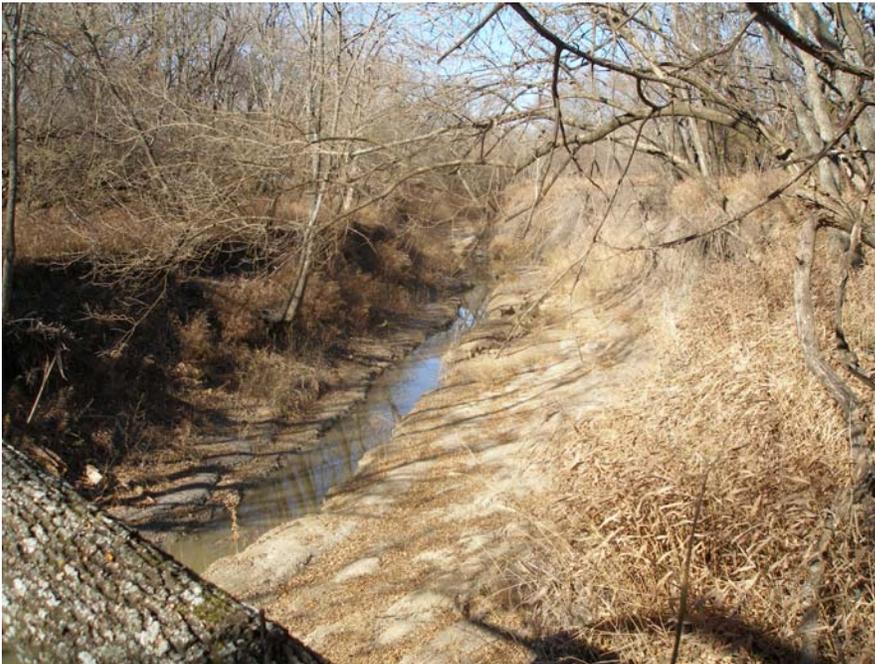
Figure 11. Severe erosion; CEM II-III; silty clay (location 49). Note the knickzone at the bottom of the channel and slope failures on the channel sides.
